BLACKROCK ESTATES
SUBDIVISION OBSERVATION REPORT

July 25, 2012

HR GREEN JOB NO. 86120056

Blackrock Estates Subdivision Observation Report

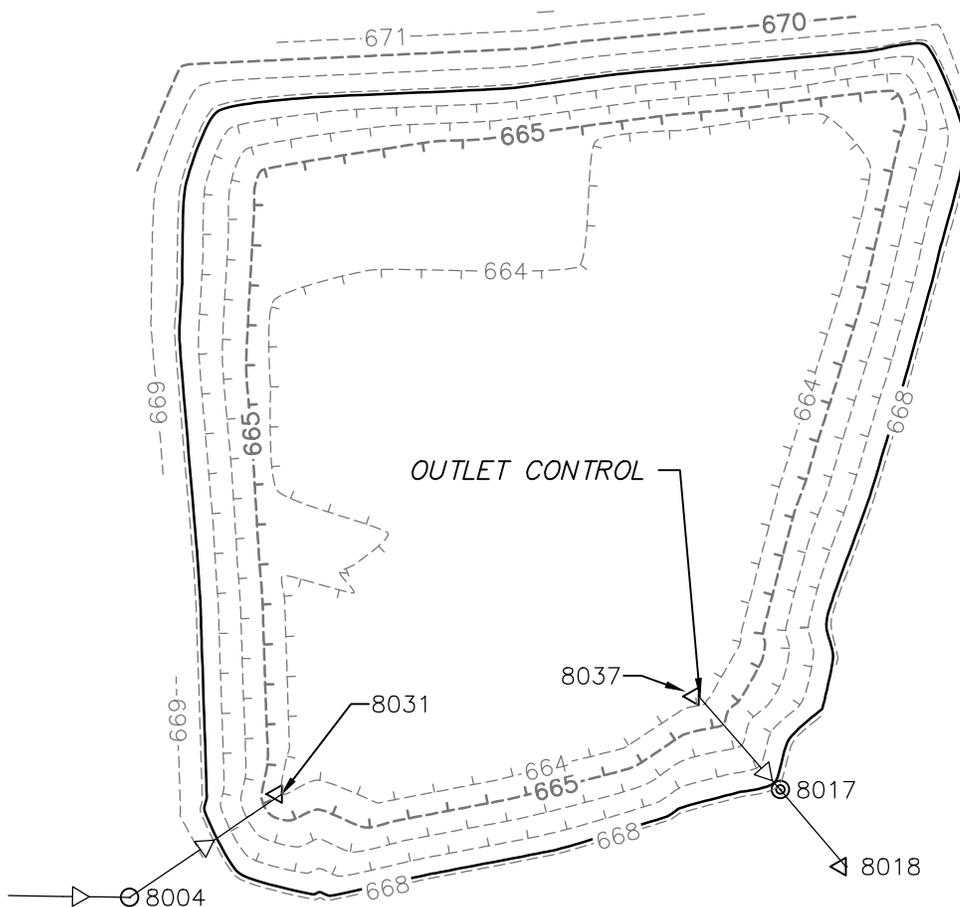
EXHIBIT B

PROPOSED	EXISTING	DIFFERENCE
WEIR WALL- TOP ELEV.	664.20	664.93	0.73' HIGH
2 YEAR RESTRICTOR INV ELEV. (diameter)	662.94 (3")	663.73 (3")	0.79' HIGH
100 YEAR RESTRICTOR INV ELEV. (diameter)	662.94 (4")	663.73 (NA)	0.79' HIGH
100 YEAR EMERGENCY OVERFLOW WEIR ELEV.	668.00	667.80	0.20' LOW

The weir wall and restrictor pipe were all constructed an average of 0.76' high. The resulting NWL and HWL elevations were also higher by a similar amount. The upstream impact of this increase could not be determined within the scope of our analysis. Our analysis does conclude that that existing pond does exceed the proposed and required storage volumes.

- LOT 6
- 8004 STORM CATCH BASIN
F/L=669.36
INV=664.26 NE 15" RCP
 - 8031 FLARED END SECTION
INV=664.00 SW 15" RCP
 - 8037 FLARED END SECTION
INV=663.64 SE 12" RCP
 - 8017 STORM MANHOLE (RESTRICTOR)
RIM=668.13
INV=663.73 NW/SE 12" RCP
TOP OF WALL=664.93
ORRFICE=663.73 3"
 - 8018 FLARED END SECTION
INV=663.53 NW 12" RCP
