CEDAR BROOKE
SUBDIVISION OBSERVATION REPORT

July 25, 2012

HR GREEN JOB NO. 86120056

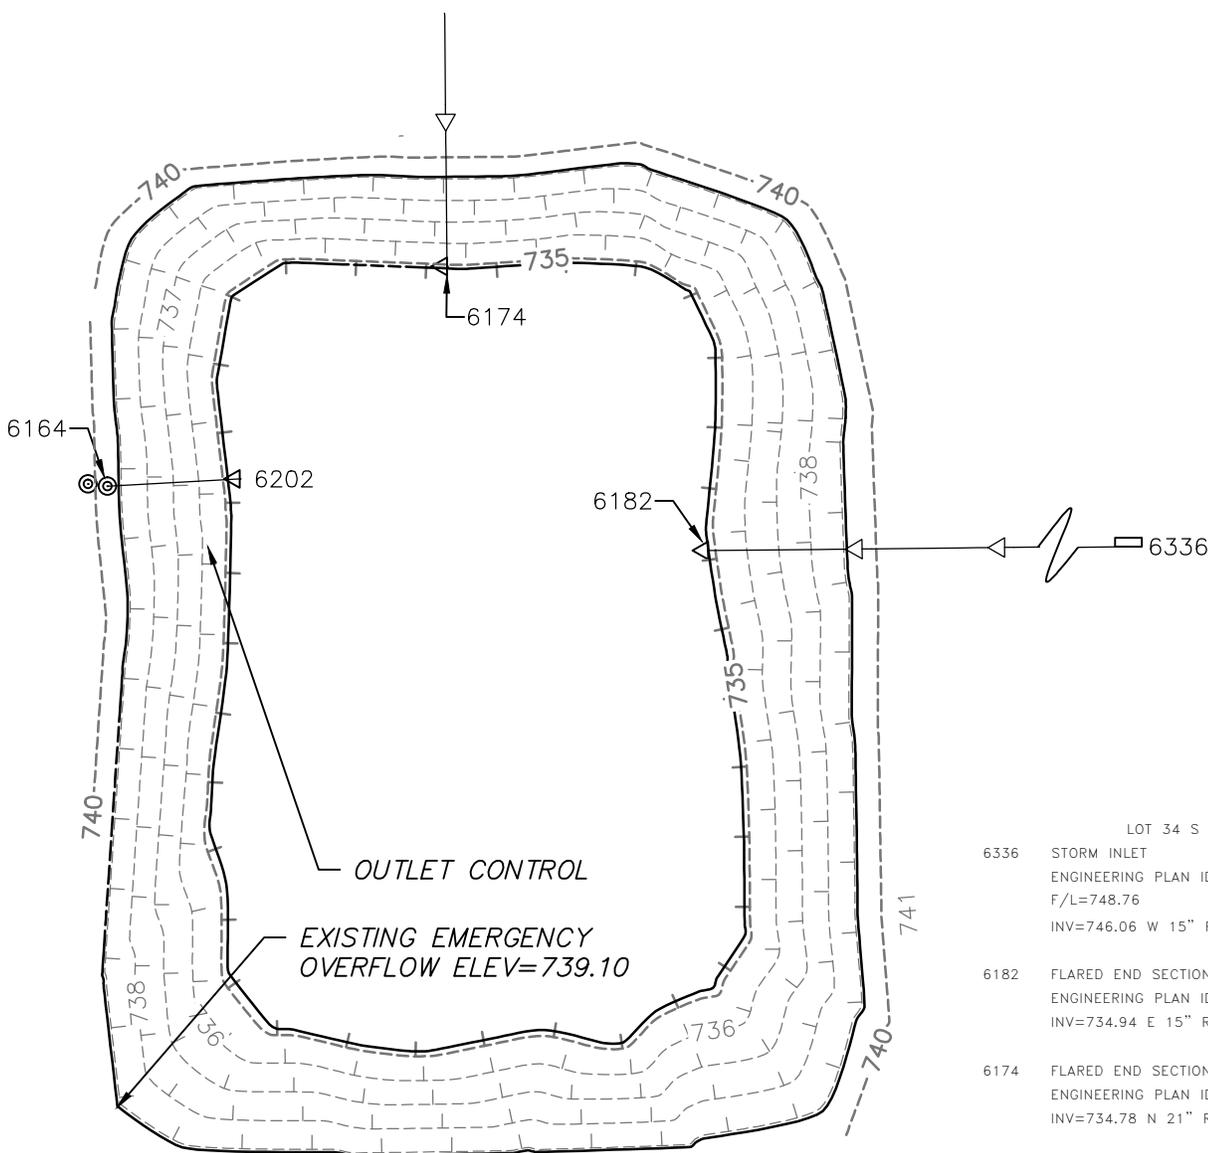
- LOT 34 S
- 6336 STORM INLET
ENGINEERING PLAN ID=ST6-1
F/L=748.76
INV=746.06 W 15" RCP
 - 6182 FLARED END SECTION
ENGINEERING PLAN ID=FES6-1
INV=734.94 E 15" RCP
 - 6174 FLARED END SECTION
ENGINEERING PLAN ID=FES8-2
INV=734.78 N 21" RCP
 - 6202 FLARED END SECTION
ENGINEERING PLAN ID=FES10-1
INV=734.83 E 24" RCP
 - 6164 STORM MANHOLE (RESTRICTOR)
ENGINEERING PLAN ID=FES10-1
RIM=742.09
INV=734.79 E 24" RCP
TOP OF WALL=739.59
ORFFICE_UPPER=737.44 4"
ORFFICE_LOWER=734.39 3"
