**Prepared for: VILLAGE OF HOMER GLEN**  
14933 S. Founders Crossing  
Homer Glen, IL 60491

**CYPRESS POINTE**  
**SUBDIVISION OBSERVATION REPORT**

**July 25, 2012**

**HR GREEN JOB NO. 86120056**

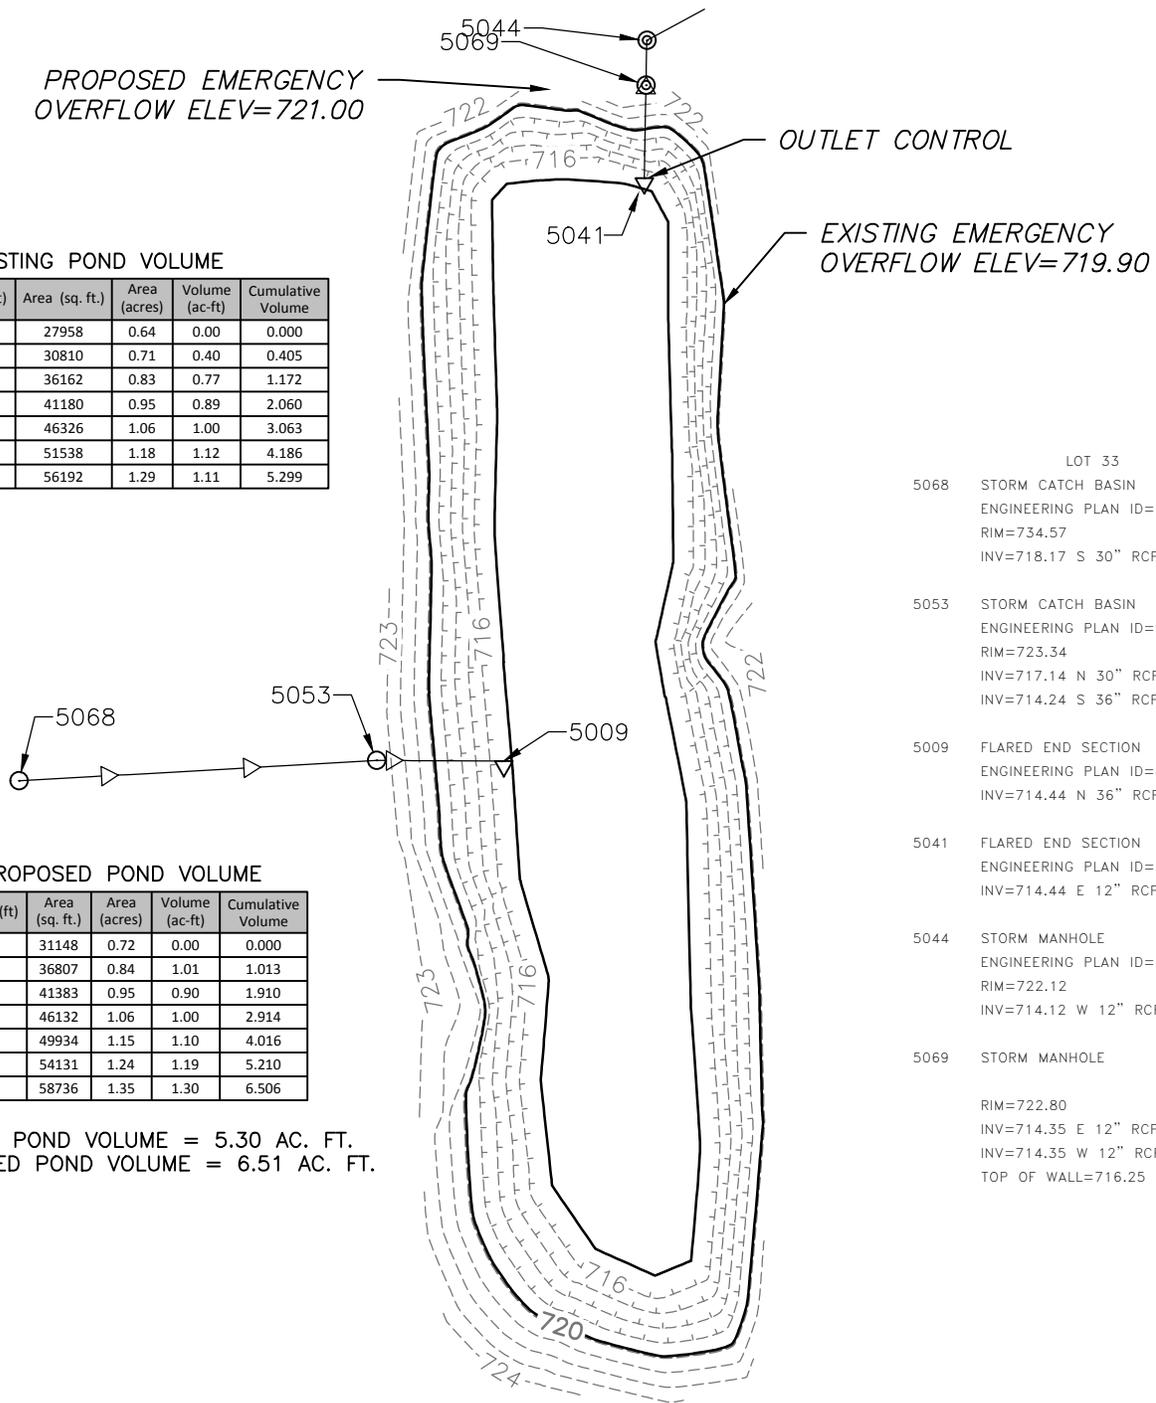
The weir wall within the restrictor manhole and the 100-year restrictor orifice were constructed 0.20' and 0.15' low respectively. The 2 and 100 year orifice elevations and sizes could not be verified. The known deviations would result in a stormwater release rate that is greater than the rate proposed. The existing 100-year emergency overflow was found to be in an alternate location and at an elevation 1.1' lower than proposed. This results in a reduced storage volume for the basin. Based on the information available we were able to determine that the existing pond has 1.21 ac.ft. less storage volume than proposed. This basin does not comply with the design plans. Our analysis concludes that the existing pond is 19% short of the proposed storage volume. If corrective measures are deemed necessary, adjustments to the overflow weir or outfall pipes can be

EXISTING POND VOLUME = 5.30 AC. FT.  
 PROPOSED POND VOLUME = 6.51 AC. FT.

- LOT 33
- 5068 STORM CATCH BASIN  
ENGINEERING PLAN ID=14  
RIM=734.57  
INV=718.17 S 30" RCP
  - 5053 STORM CATCH BASIN  
ENGINEERING PLAN ID=9  
RIM=723.34  
INV=717.14 N 30" RCP  
INV=714.24 S 36" RCP
  - 5009 FLARED END SECTION  
ENGINEERING PLAN ID=8  
INV=714.44 N 36" RCP
  - 5041 FLARED END SECTION  
ENGINEERING PLAN ID=3  
INV=714.44 E 12" RCP
  - 5044 STORM MANHOLE  
ENGINEERING PLAN ID=2  
RIM=722.12  
INV=714.12 W 12" RCP
  - 5069 STORM MANHOLE

RIM=722.80  
INV=714.35 E 12" RCP  
INV=714.35 W 12" RCP  
TOP OF WALL=716.25

evaluated. A detailed analysis of the original design calculations and existing site conditions would be necessary. HR Green can provide this service for an additional cost.
