Prepared for: VILLAGE OF HOMER GLEN
14933 S. Founders Crossing
Homer Glen, IL 60491

ERIN HILLS – UNIT 4D
SUBDIVISION OBSERVATION REPORT

July 25, 2012

HR GREEN JOB NO. 86120056

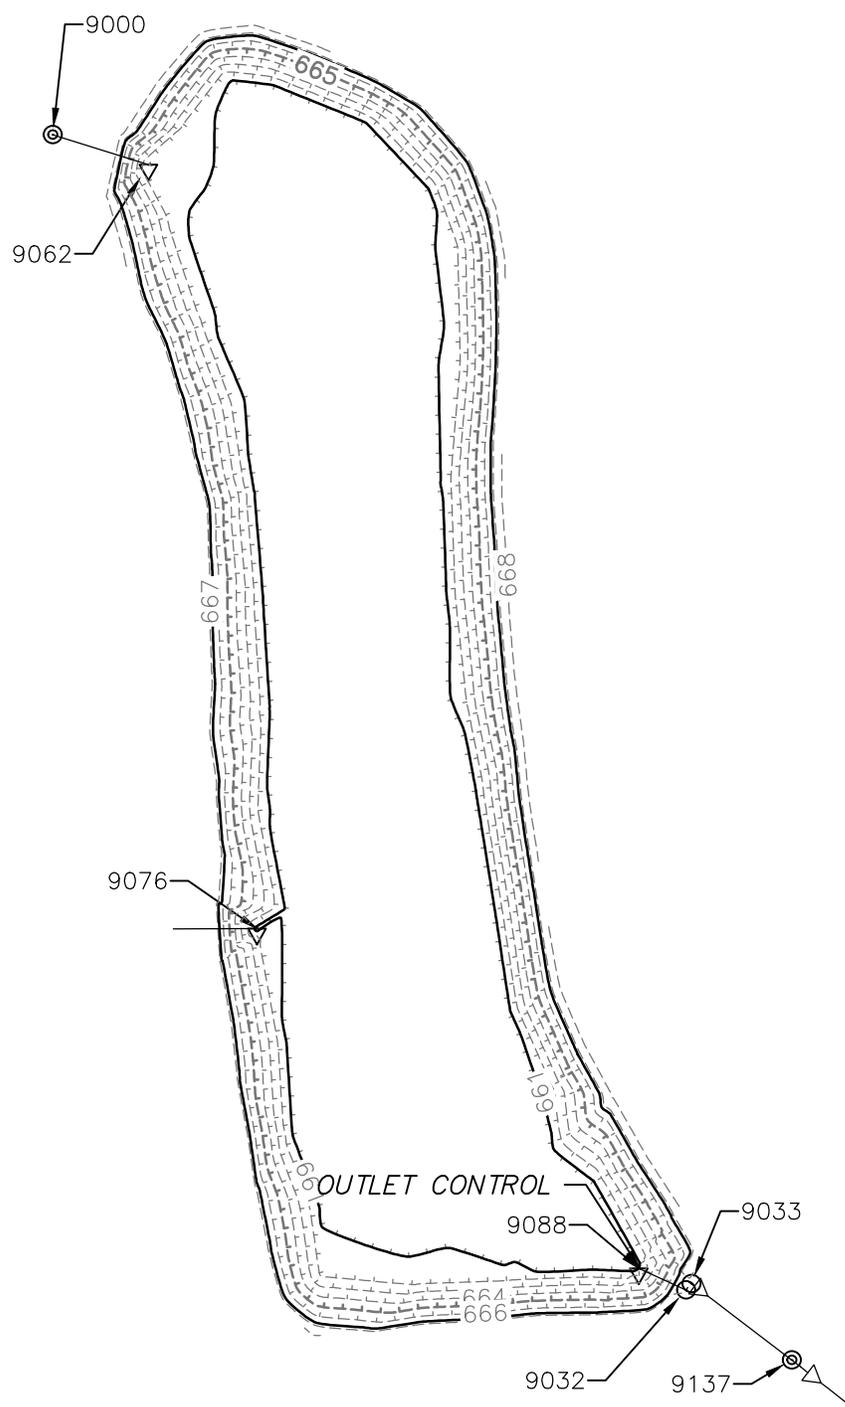
BASIN #1

For Basin #1, the surveyed storage volume is calculated to be 12.12 Ac-ft. The design plans label this basin as providing 14.10 Ac-ft of storage. The corresponding difference between design storage and as-built storage volume provided is approximately 2.0 Ac-ft or a 14% shortage. The design plans call for Basin#1 to have a normal water level (NWL) of 660.80 and a 100-YR high water level (HWL) of 667.8 or 667.30 (listed both ways on the plans). The surveyed NWL was found to be based upon the flared end section (FES) #9088, invert (INV) elevation of 661.0±. The HWL was found to be the ground elevations of 666.70 at the overflow weir near CB #9032.

Basin #1 is short in volume due to the fact that the outfall pipe was constructed 0.2' high and the overflow weir was constructed 1.1' low. One possible corrective measure would be to raise the basin overflow weir and containment berm to obtain additional volume. A detailed analysis of the original design calculations and existing site conditions would be necessary before this measure could be recommended. HR Green can provide this service at an additional cost.

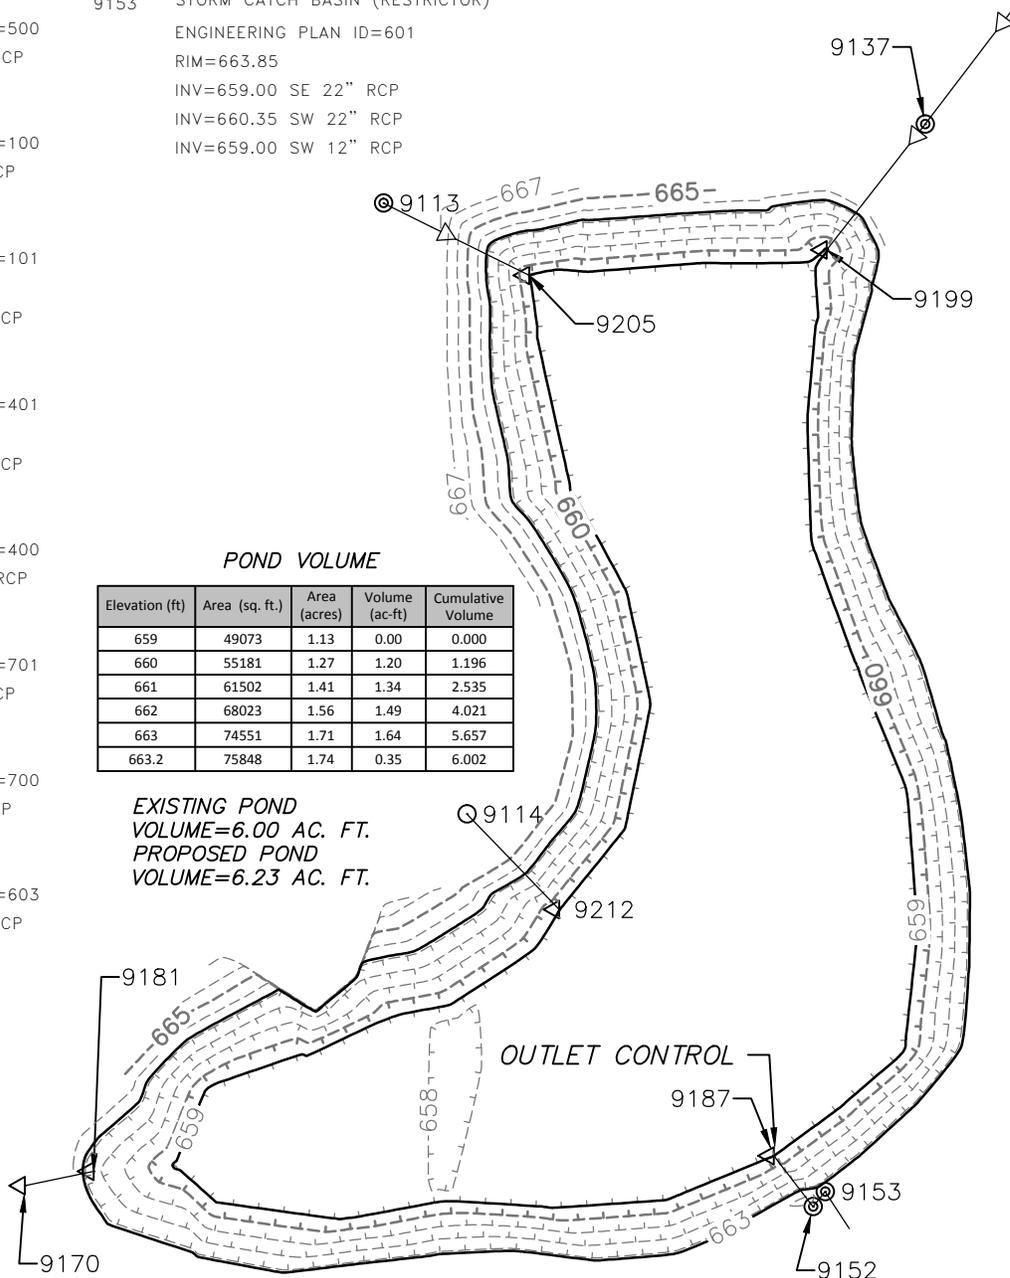
For Basin #2, the surveyed storage volume is calculated to be 6.00 Ac-ft. The design plans label this basin as providing 6.23 Ac-ft of storage. The corresponding difference between design storage and as-built storage volume provided is approximately 0.2 Ac-ft or a 4% shortage. The design plans call for Basin #2 to have a normal water level (NWL) of 659.00 and a 100-YR high water level (HWL) of 663.00. The surveyed NWL was found to be based upon the flared end section (FES) #9187, invert (INV) elevation of 659.00. The HWL was found to be the ground elevations of 663.20 at the overflow weir along the pond's eastern bank.

Basin #2 is also short in volume by 4% of the proposed design. The NWL and HWL elevations match the proposed design. If corrective measures are deemed necessary adjustments to the overflow weir or outfall pipe can be evaluated. Likewise, a detailed analysis of the original design calculations and existing site conditions would be necessary. HR Green can provide this service at an additional cost.

EXISTING POND VOLUME=6.00 AC. FT.
 PROPOSED POND VOLUME=6.23 AC. FT.
