Prepared for: VILLAGE OF HOMER GLEN
14933 S. Founders Crossing
Homer Glen, IL 60491

GLENVIEW WALK ESTATES
SUBDIVISION OBSERVATION REPORT

July 25, 2012

HR GREEN JOB NO. 86120056

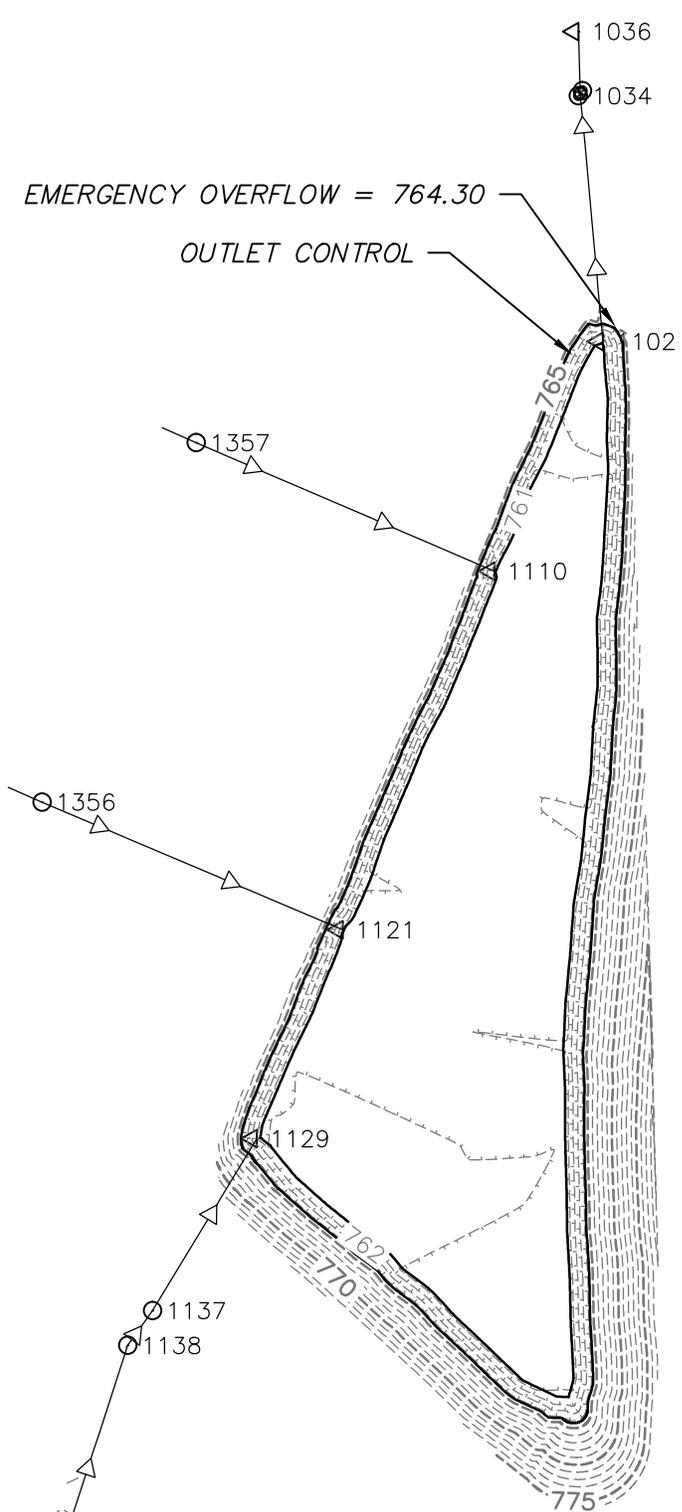
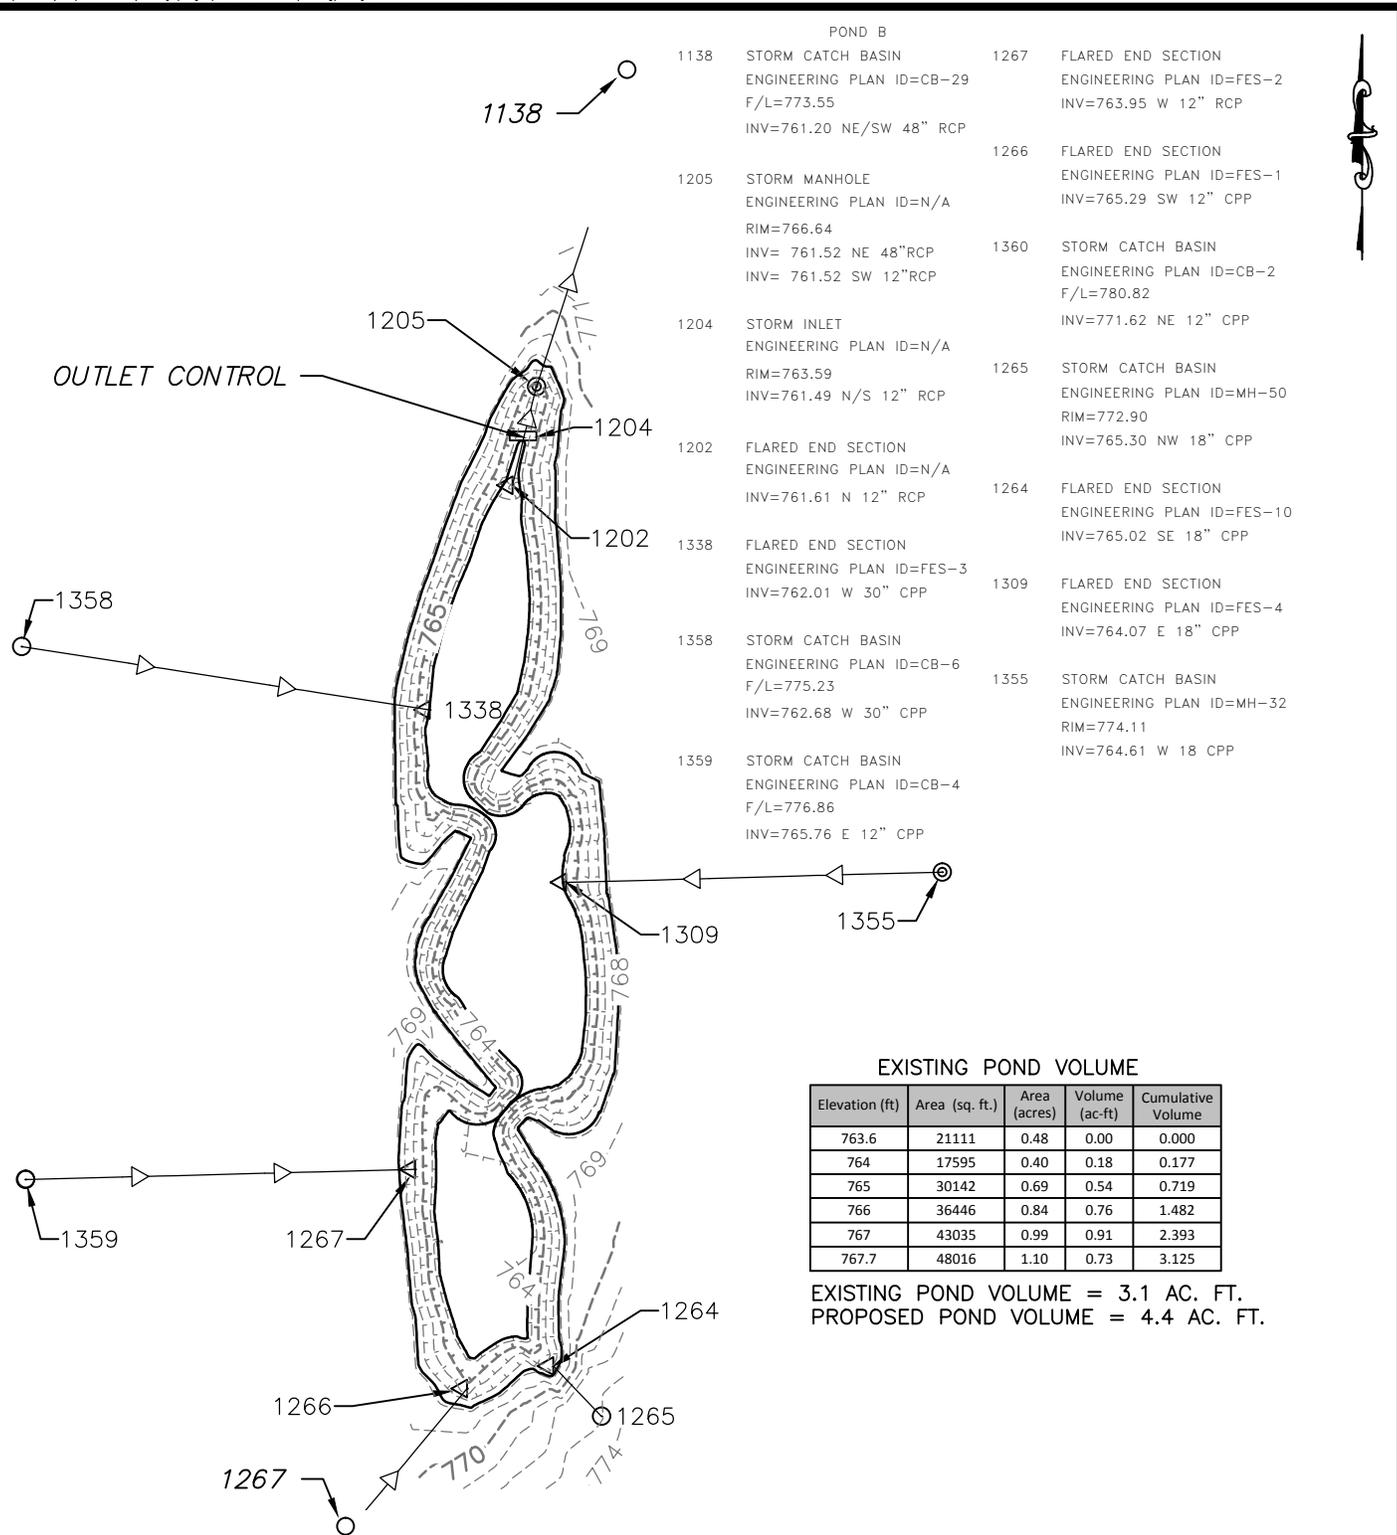
The combined shortage of storage volume for both ponds is 3.85 ac.ft which is a 25% lower than the proposed volume. If corrective measures are deemed necessary, adjustments to the overflow weir or outfall pipes can be evaluated. Likewise, a detailed analysis of the original design calculations and existing site conditions would be necessary. HR Green can provide this service at an additional cost.
