**KING DRIVE**  
**SUBDIVISION OBSERVATION REPORT**

**July 25, 2012**

**HR GREEN JOB NO. 86120056**

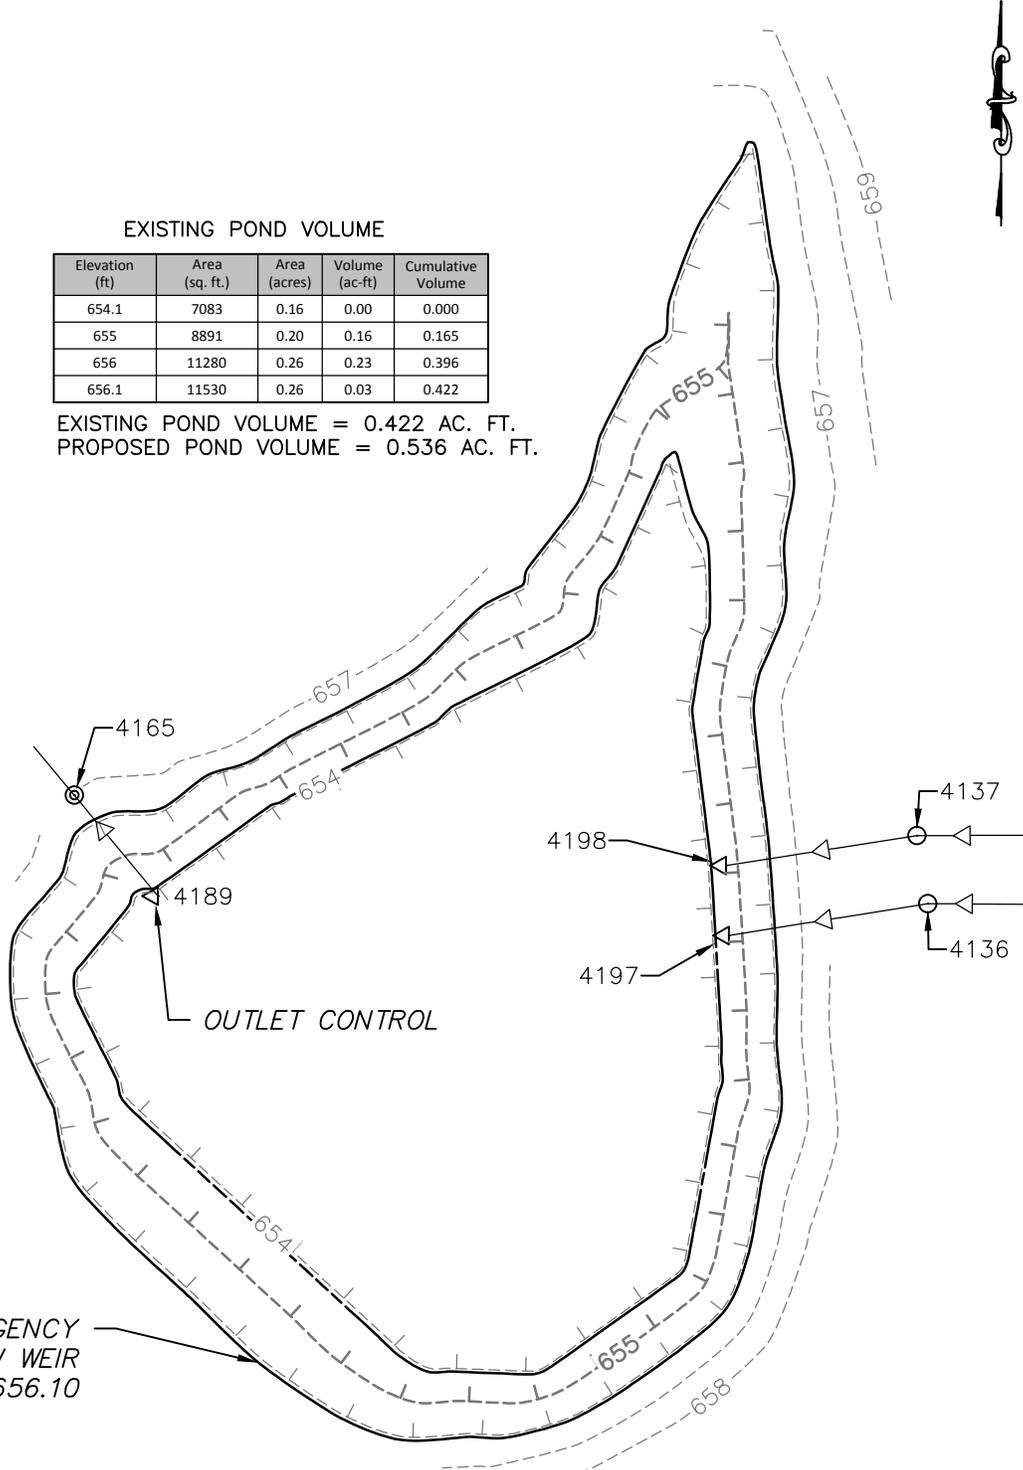
KING DRIVE  
 POND A

In Pond A the diameter of the 2 year restrictor orifice was constructed 1.50" larger than was proposed. The 100-year restrictor orifice was constructed 0.32" larger than was proposed. These deviations would result in a stormwater release rate that is greater than the rate proposed. The 100-year emergency overflow was constructed 1.0' lower than the proposed elevation. This results in a reduced storage volume for the basin. This basin does not comply with the design plans. A detailed review of the original drainage calculations or a hydraulic analysis would be required to determine the impact of these deviations.

EXISTING POND VOLUME = 0.422 AC. FT.  
 PROPOSED POND VOLUME = 0.536 AC. FT.

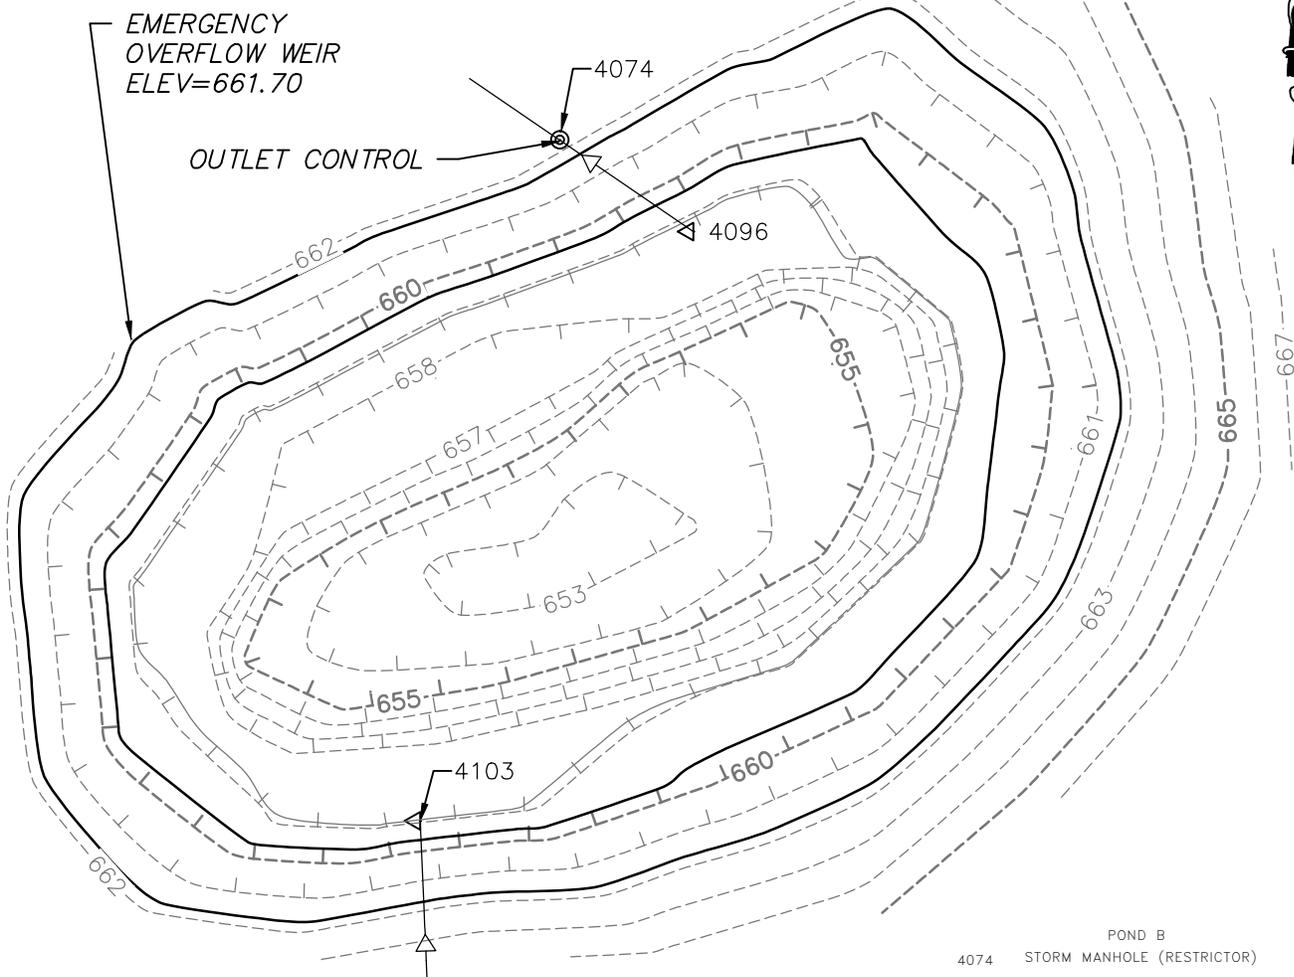
KING DRIVE  
 POND B

Pond B was proposed to be a wet pond. At the time of our survey it was not holding any water. This may be a result of the current dry conditions or the bottom of the pond may not be sealed properly. The differences noted above for Pond B do not result in negative impact on the storage volume or release rates for the pond. The pond is in general conformance with the design plans.

EXISTING POND VOLUME = 0.570 AC. FT.  
 PROPOSED POND VOLUME = 0.474 AC. FT.

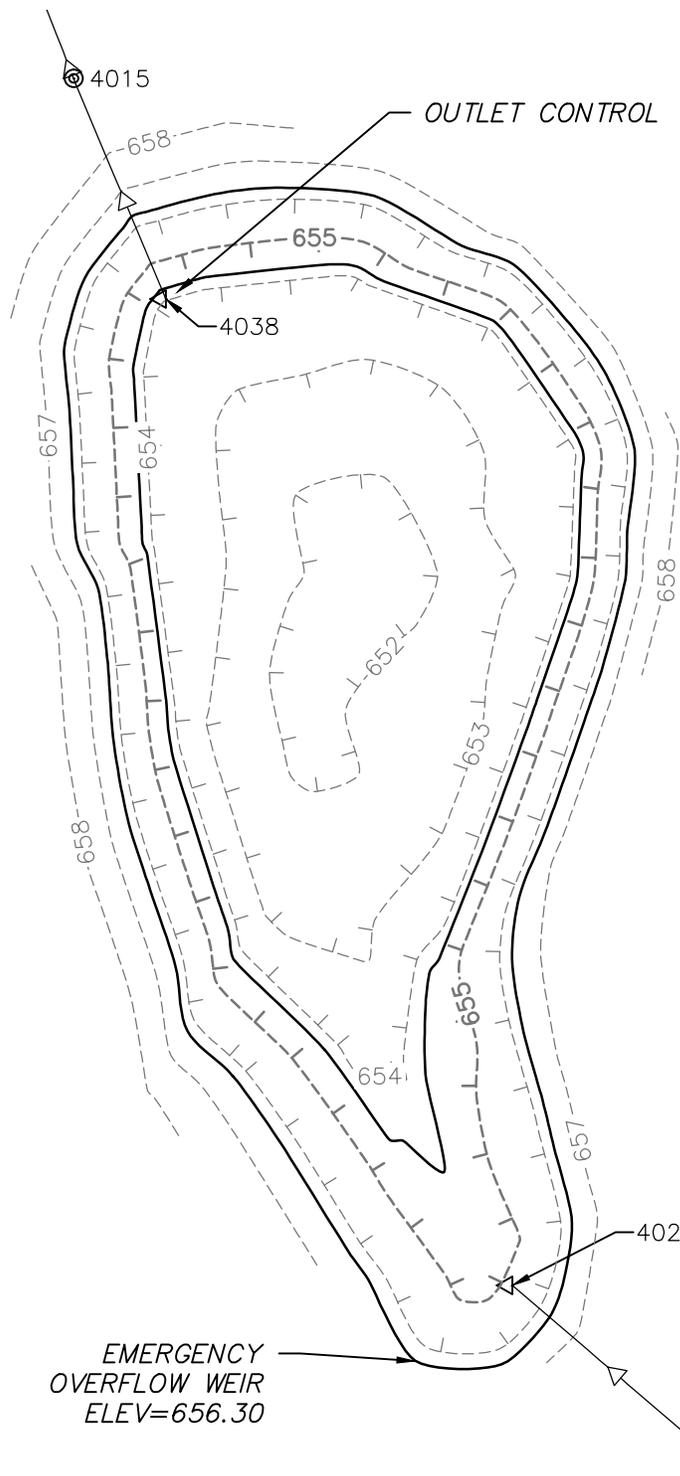
KING DRIVE  
 POND C

Pond C was proposed to be a wet pond. At the time of our survey it was not holding any water. This may be a result of the current dry conditions or the bottom of the pond may not be sealed properly. In Pond C the diameter of the 100-year restrictor orifice was constructed 0.50" larger than was proposed. This deviation would result in a stormwater release rate that is great than the rate proposed. The 100-year emergency overflow was constructed 1.8' lower than the proposed elevation. This results in a reduced storage volume for the basin. This basin does not comply with the design plans. A detailed review of the original drainage calculations or a hydraulic analysis would be required to determine the impact of these deviations.

EXISTING POND VOLUME = 0.347 AC. FT.  
 PROPOSED POND VOLUME = 0.624 AC. FT.
