**Prepared for: VILLAGE OF HOMER GLEN**  
14933 S. Founders Crossing  
Homer Glen, IL 60491

**EVLYN'S GATE NORTH**  
**SUBDIVISION OBSERVATION REPORT**

**July 25, 2012**

## **Evlyn's Gate North Subdivision Observation Report**

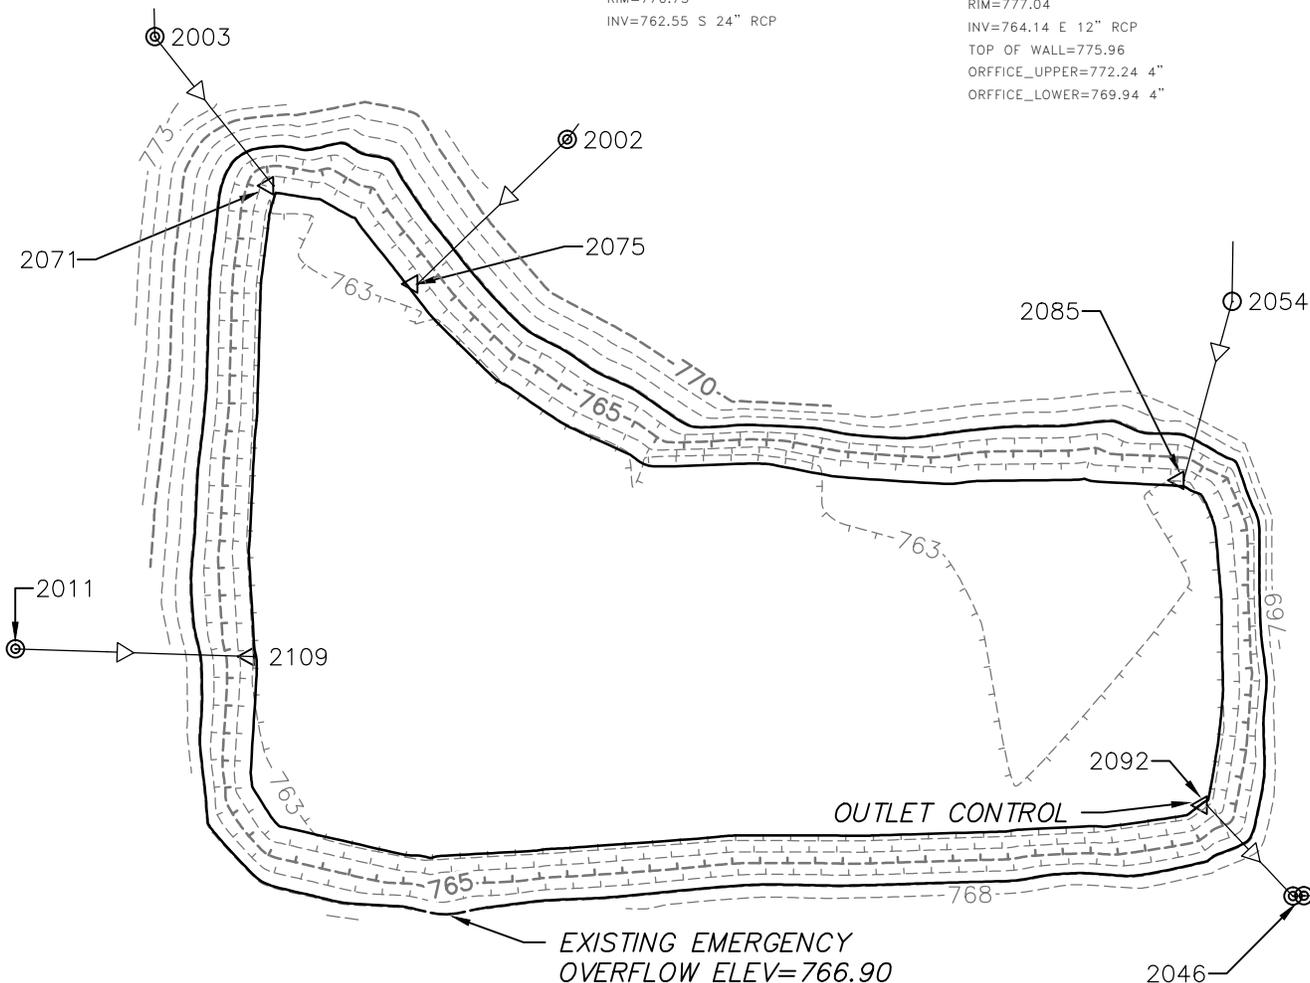
| 2002 | STORM MANHOLE<br>ENGINEERING PLAN ID=CB-202<br>F/L=770.46<br>INV=762.66 SW 48" RCP | 2109 FLARED END SECTION<br>ENGINEERING PLAN ID=N/A<br>INV=762.92 W 12" RCP |
| 2054 | STORM MANHOLE<br>ENGINEERING PLAN ID=MH-101<br>RIM=770.75<br>INV=762.55 S 24" RCP | 2011 STORM MANHOLE (RESTRICTOR)<br>ENGINEERING PLAN ID=N/A<br>RIM=777.04<br>INV=764.14 E 12" RCP<br>TOP OF WALL=775.96<br>ORFFICE_UPPER=772.24 4"<br>ORFFICE_LOWER=769.94 4" |
